ARMY AVIATION TEST BOARD FORT RUCKER ALA
PRODUCT-IMPROVEMENT TEST OF OH-6A ROTOR BLADES WITH INCREASED T--ETC(U)
DEC 68

SUBJECT: Final Report of Product-Improvement Test of OH-6A
Rotor Blades with Increased Twist and Contour Tolerances.
USATECOM ~~XXXXXXXXXX~~ 4-6-1251-18

SUBJECT: Final Report of Product-Improvement Test of OH-6A Rotor
Blades with Increased Twist and Contour Tolerances,
USATECOM Project No. 4-6-0251-18

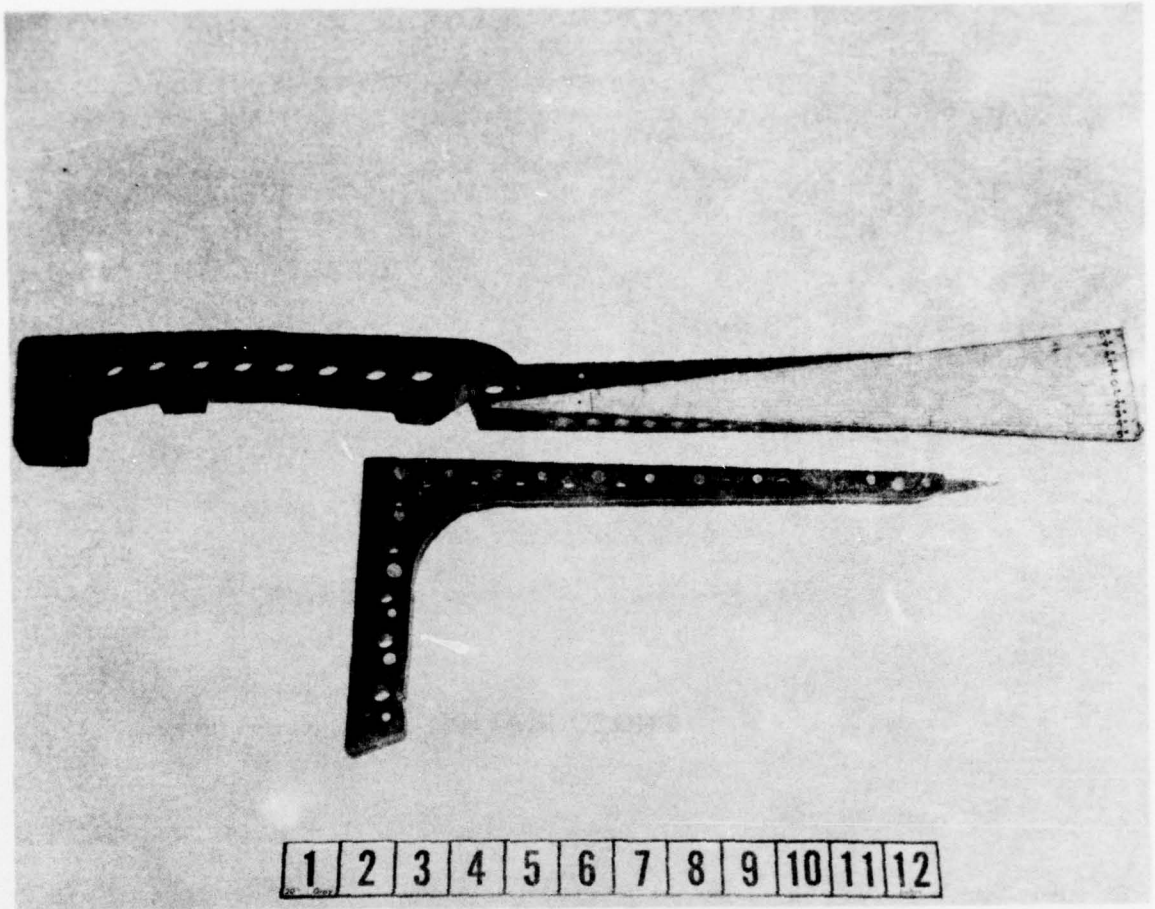
Figure 1.

- d. Accurate trim tab or pitch change link adjustments were not possible with existing tools. Locally manufactured tools (figures 1 and 2, inclosure 4) were used during the test.

c. Tools suitable for accurate adjustment of trim tabs and pitch-change links be provided to units equipped with the OH-6A.
